Exhibit 13C

Letter from Captain Mohsen El Missiry, dated 7/27/00,
Egyptian Delegation comments on
Group Chairman's Aircraft Performance Study Addendum 1

July 19, 2000

OUTBOARD AILERONS ASSYMETRIC OPERATION ANALYSIS

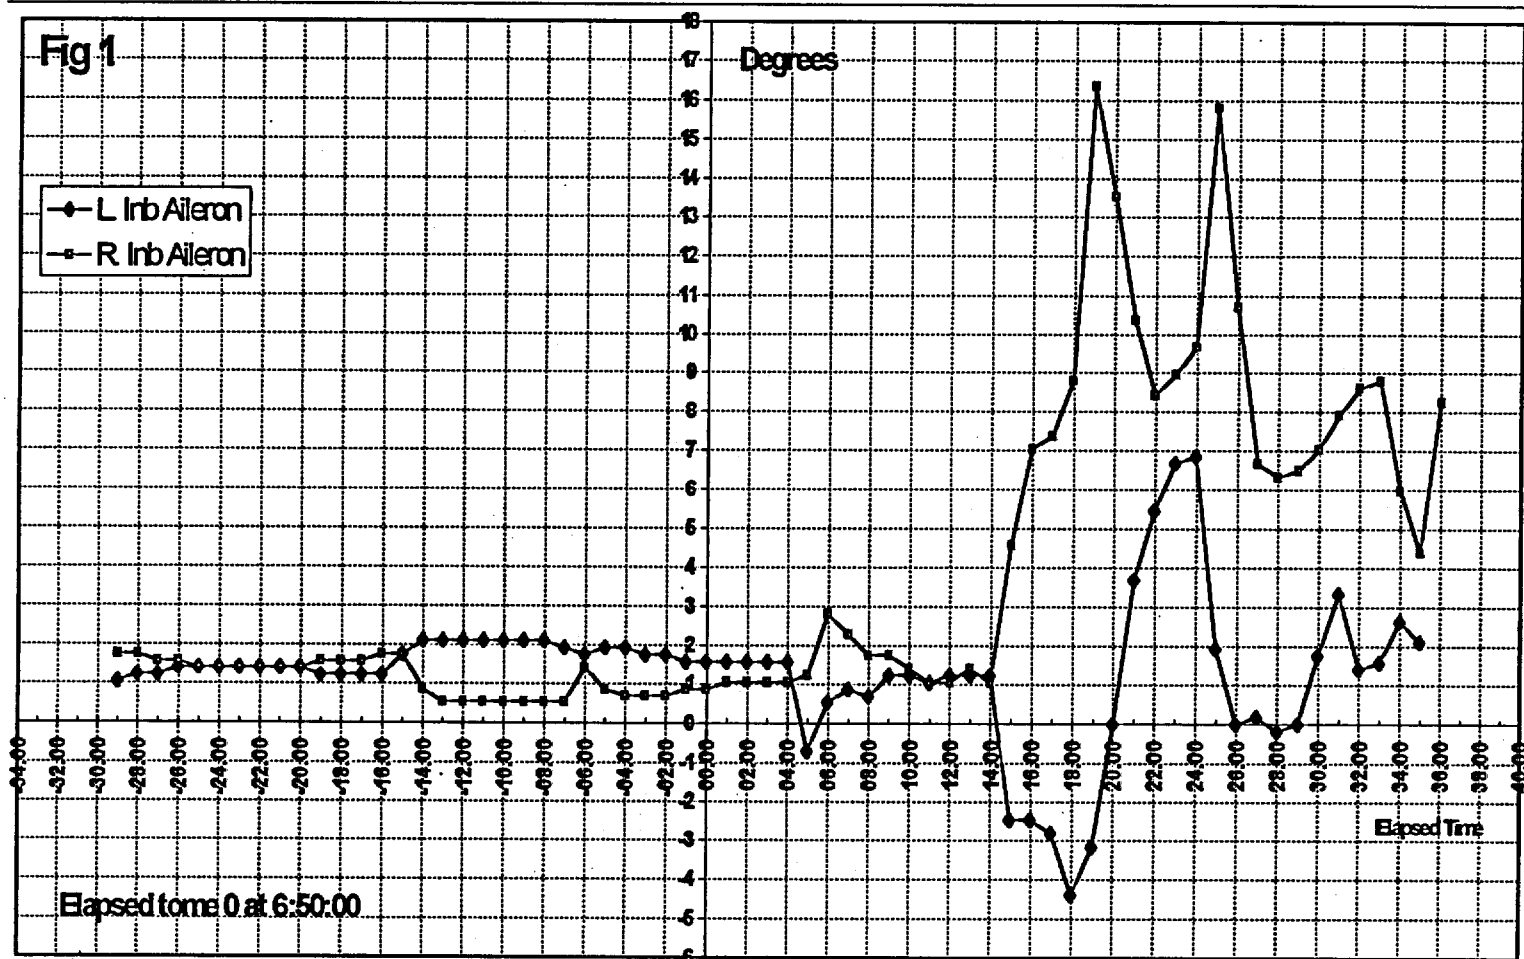
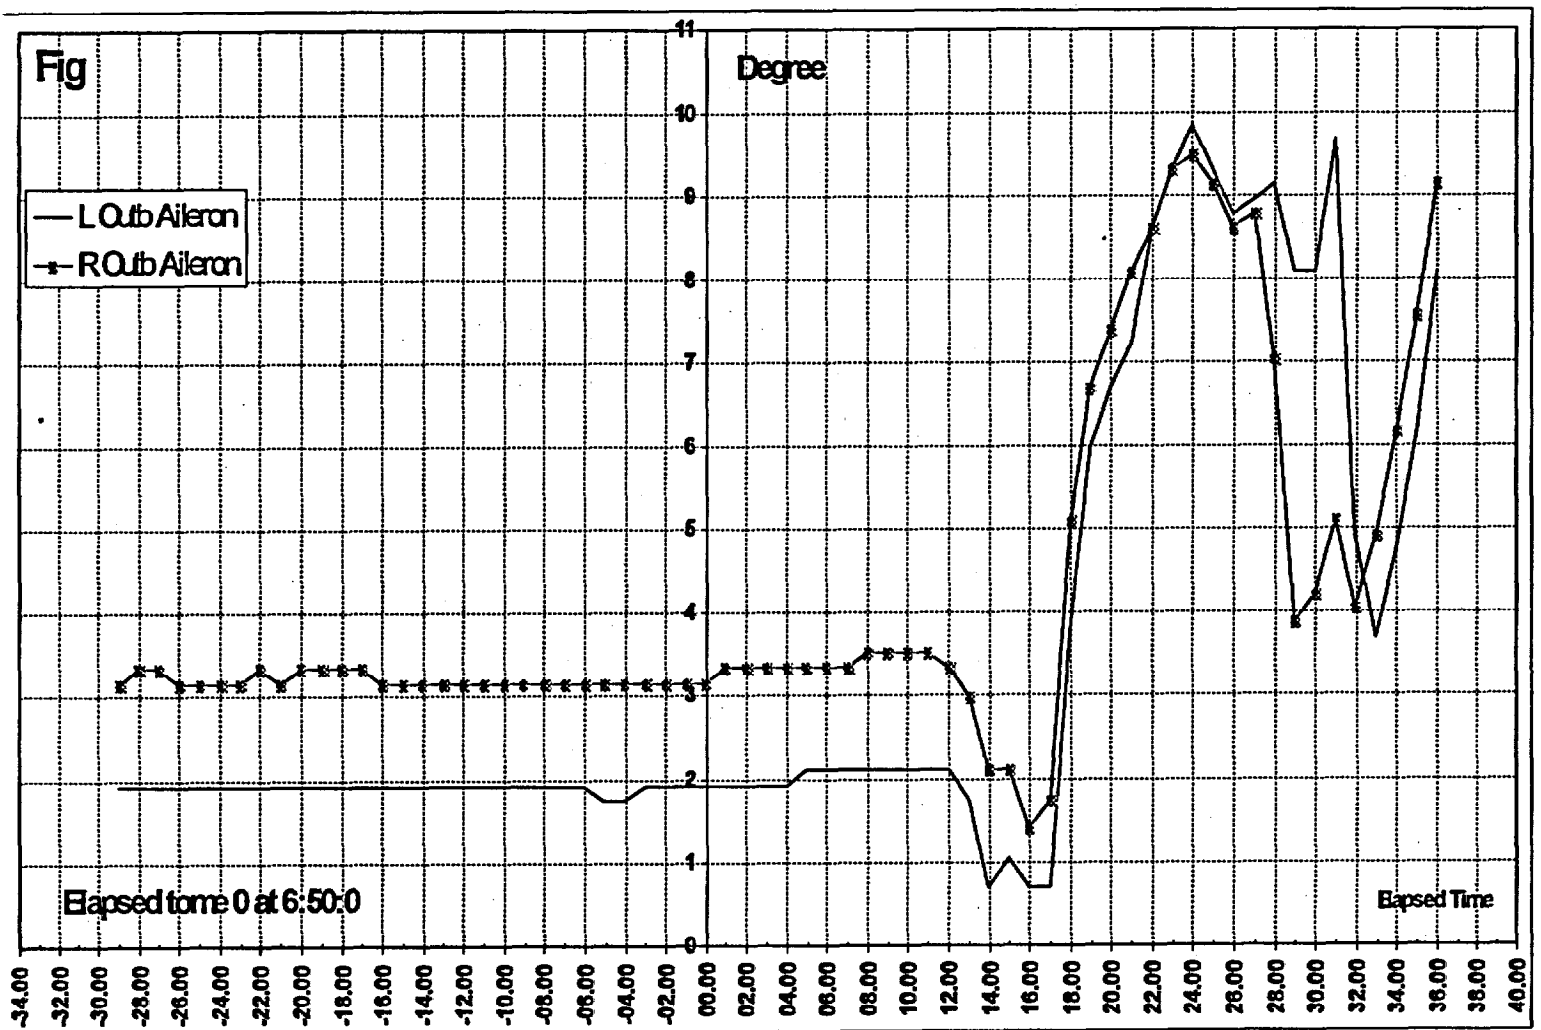
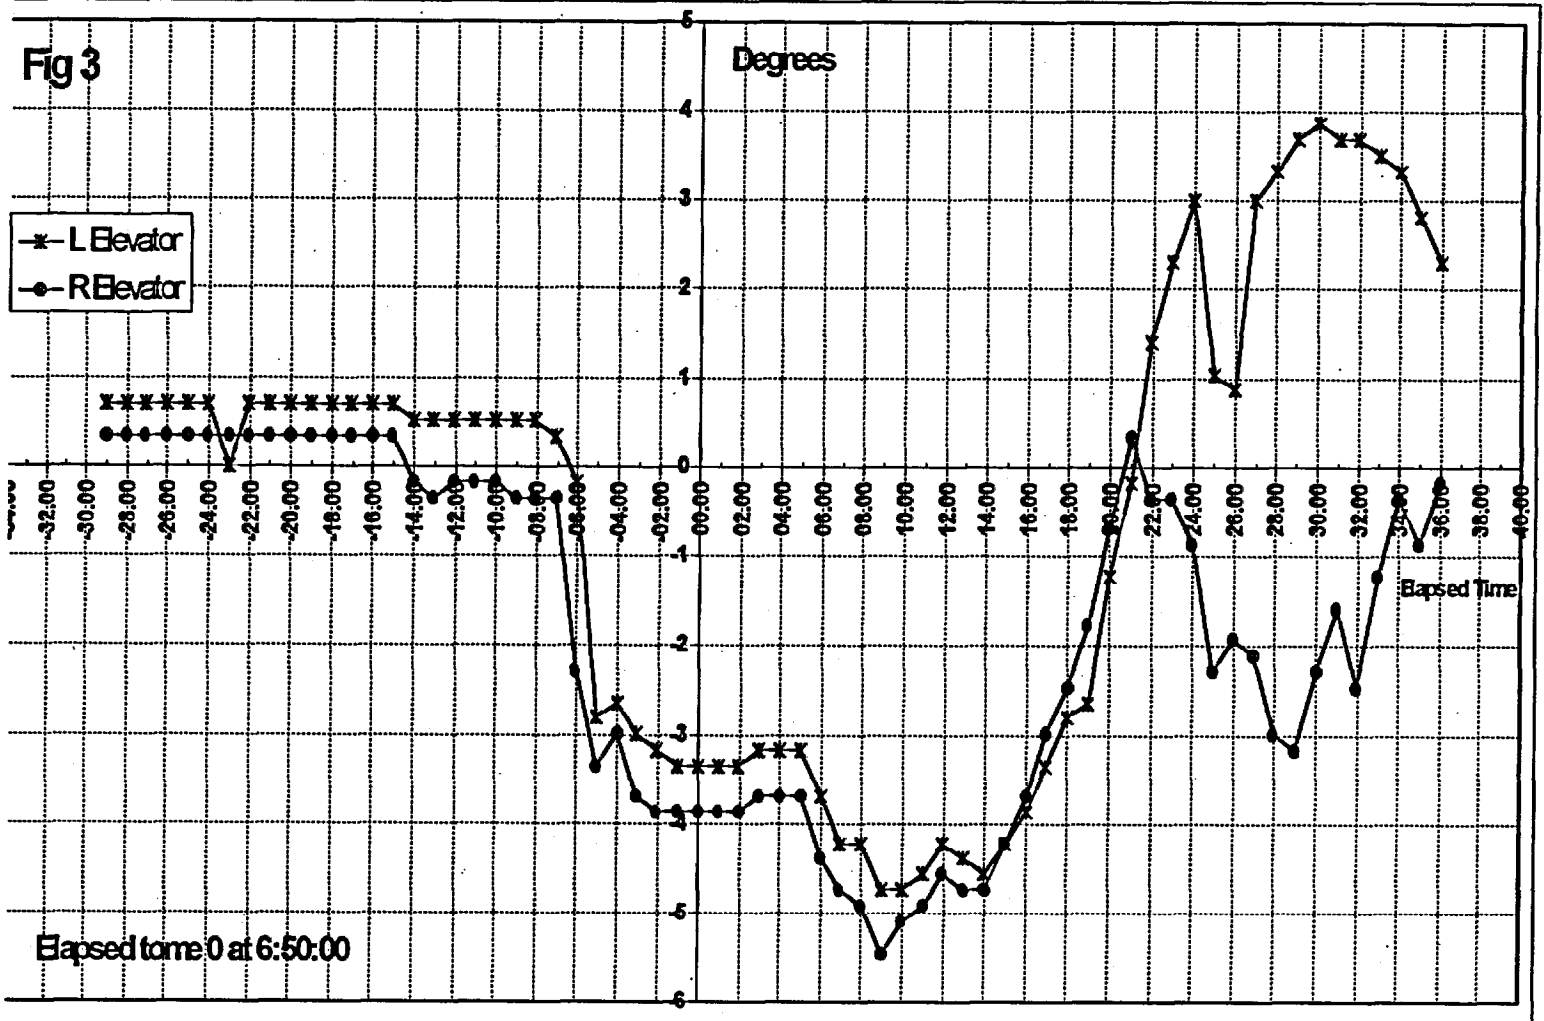
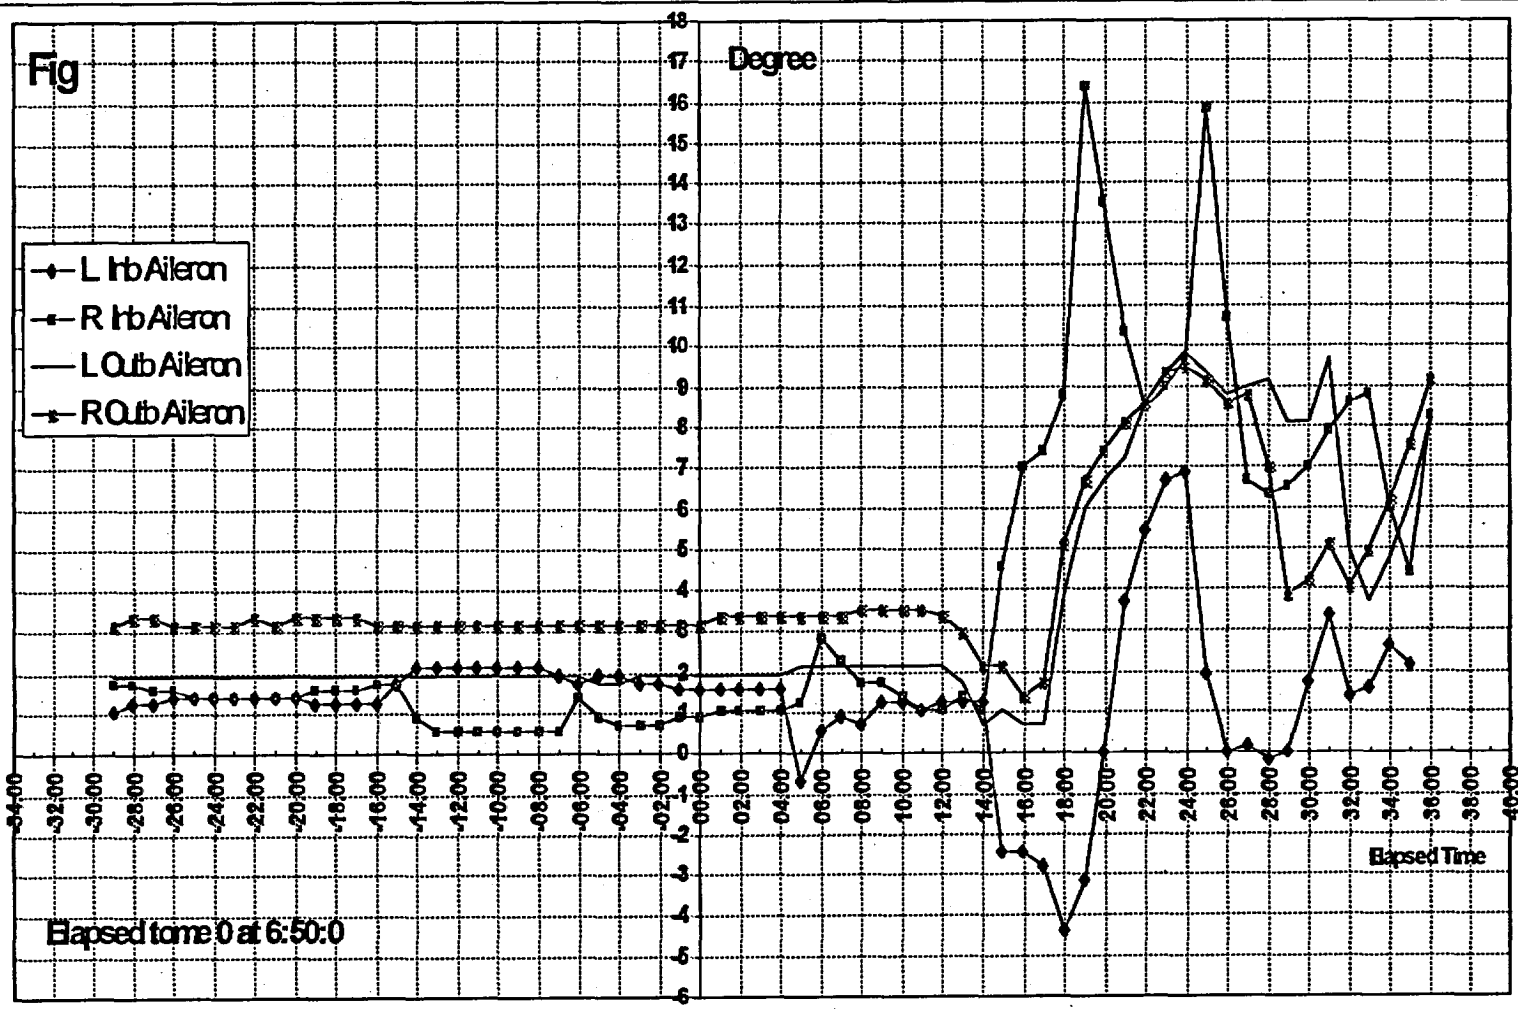
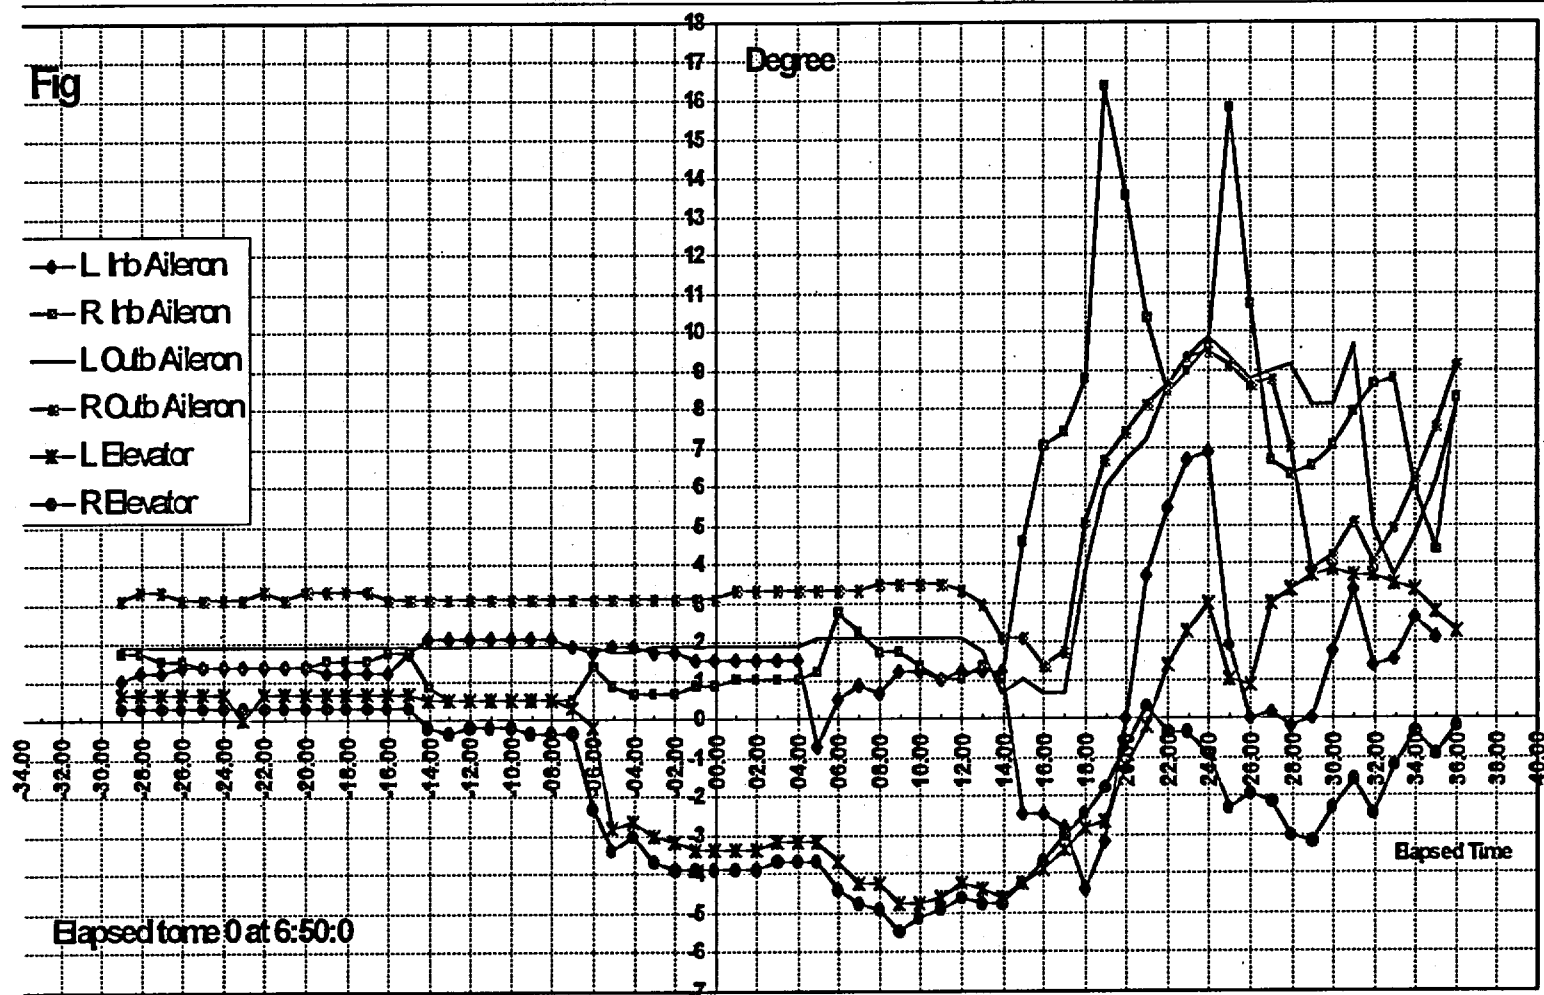
- Analysis of the FDR data showed non normal behavior of the inboard ailerons, outboard ailerons and elevators at the end of the airplane dive (figures 1 to 5)

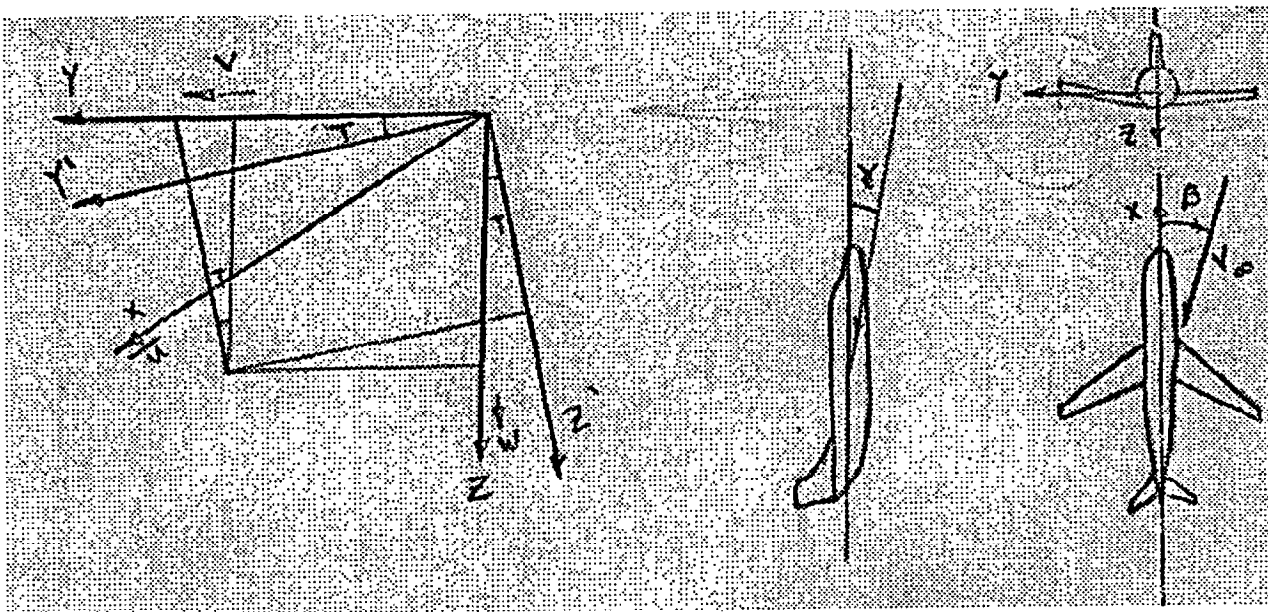
Side Slip Effect:

The dihedral angle of the wing is 6 degrees. This angle will cause one wing to be at a different angle of attack than the other while in a sideslip.

The above table shows that, to change the wing angle of attack by 5 degrees (difference of 10 between the wings) requires a sideslip angle of about 40 degree. Such a sideslip angle is inconsistent with the lateral load factor, aileron angles, and rudder angles recorded on the DFDR, and at the flight condition in question is probably beyond the aerodynamic and structural capability of the airplane.

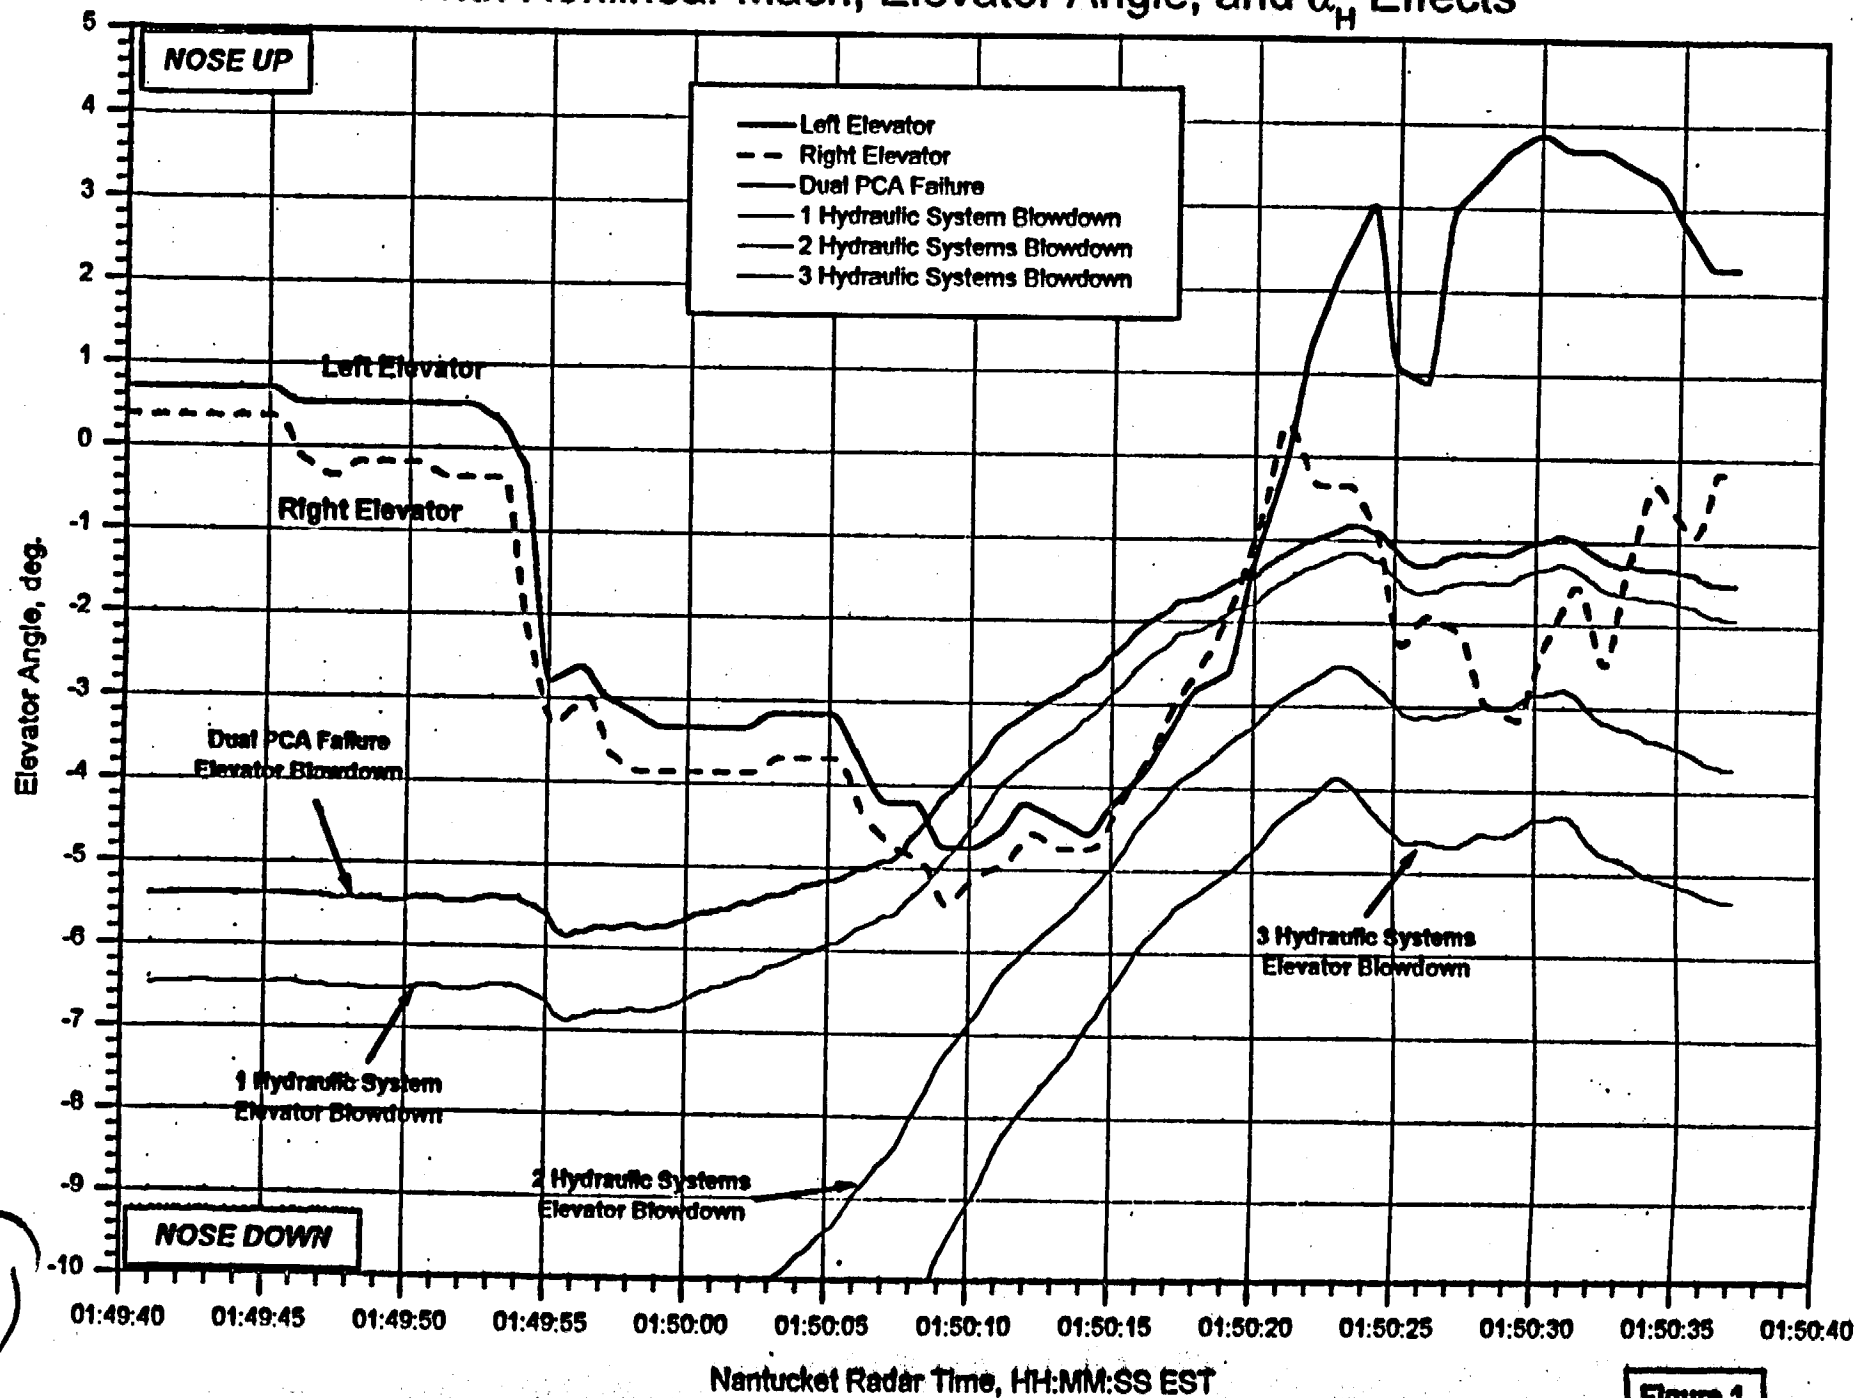
The solutions for δ_e with $n = 0.78, 1, 2$, and 3 are shown in Figure 1. These solutions are the blowdown angles corresponding to the Dual PCA Failure and various hydraulic systems turned off. The elevator positions recorded on the DFDR are also shown in Figure 1. The elevator blowdown angle is primarily dependent on the dynamic pressure, decreasing as dynamic pressure increases. Changes in angle of attack produce oscillations about the general trend set by the increasing dynamic pressure. Nonlinear Mach effects become more pronounced after about 01:50:07, where the Mach number is increasing through 0.86 and the slope of the blowdown curves changes abruptly. The extrapolated C_H data provided by Boeing indicates that the C_H for a given δ_e deflection starts to increase significantly above Mach 0.86 , and at Mach 0.98 reaches over twice its Mach 0.8 value for some values of δ_e and α_H .

The Addendum also presents the elevator blowdown angles corresponding to different numbers of hydraulic systems powered on and off, and to a Dual Elevator PCA Failure scenario. The blowdown angles are estimated using extrapolated, non-linear elevator hinge moment data. The results of the calculations are shown in Figure 1.
